Bayley Place is a continuing care retirement community. It is a non-profit ministry of the Sisters of Charity of Cincinnati.

### A Three-Part Solution

# Case Study

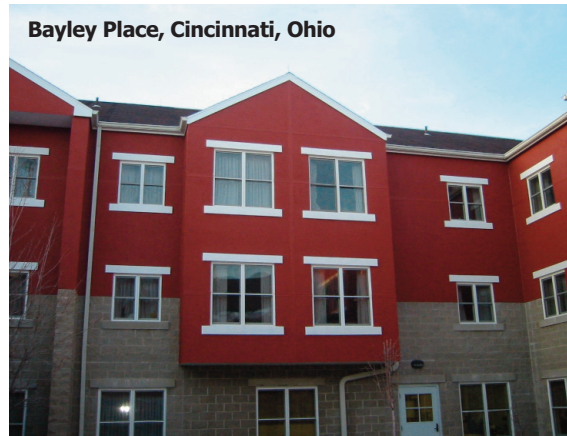
Bayley Place had repeatedly experienced leak and maintenance issues due to failed polyurethane sealant in the building joints. The joints were cut out and re-caulked with polyurethane multiple times, but each time the polyurethane would degrade and the leaks would reappear. In spring 2003, the Bayley Place facility manager hired Houston Brothers Waterproofing Inc. to create a more durable remediation program to resolve the issue.

Houston Brothers knew from experience that the typical recommendation for this type of water problem---cutting out the old polyurethane sealant from the joints and resealing them using a silicone sealant in a standard joint configuration---might not be optimal in these circumstances. Removing old polyurethane sealant from exterior insulation finish systems (EIFS) joints and installing new sealant can be labor intensive and costly. EIFS can be easily damaged during the removal process and difficult to repair. Looking to provide the best solution for their customer, Houston Brothers called a representative for GE sealants. The representative examined the structure and proposed a solution that would prove to be faster, more effective and less expensive. The solution consisted of bridging over the existing failed polyurethane joints with UltraSpan\* US1100 pre-cured silicone weatherstrip adhered with SilPruf\* SCS2000 silicone sealant, and then coating the exterior with SilShield\* SEC2400 silicone elastomeric coating.

Some of the existing building joints were covered by a decorative metal extrusion. These existing metal joint covers were removed and over fifty rolls of two-inch, three-inch and four-inch wide UltraSpan weatherstrip were installed using SilPruf silicone sealant as the adhesive to provide a long-lasting flexible seal at these joint locations.

An added benefit of Silshield silicone coating is that it can be made to order in custom colors. For this project, a rich red color of SilShield silicone coating was painted over the existing EIFS and white was chosen for the window sills & trim. A total of 1,380 gallons of SilShield silicone coating was used for this repair project. "GE silicone products' good system compatibility enabled us to design a permanent remedial program that not only addressed the moisture related issues at Bayley Place but also enhanced its aesthetic appeal," said Neal.
